Manhole Inspection Summary

Manhole # S29E__019MH

Location Address: **630 Fayette St**

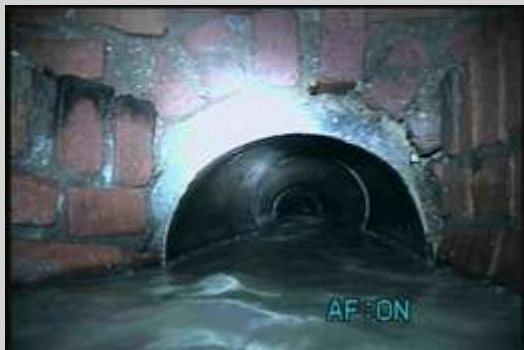
12 O'Clock Outflow

12 in. Circular Gravity Sewer
Pipe Out @ 12 O'Clock

Pipe Material: **Clay** ☐ Pipe Lined

Invert Depth: **12.00** (ft.) Flow Characteristics: **Fast**

Deposits: ☒ None ☐ Mud ☐ Sludge ☐ Debris ☐ Grease

Infiltration: **None** Pipe Seal Cond: **Unknown**

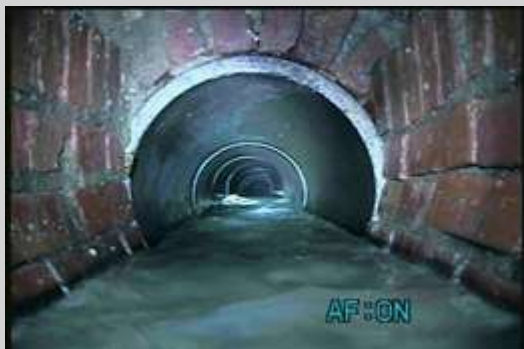
6 O'Clock Inflow

12 in. Circular Gravity Sewer
Pipe In @ 6 O'Clock

Pipe Material: **Clay** ☐ Pipe Lined

Infiltration: **None** Pipe Seal Cond: **Unknown**
